Precautions for Soldering (page-1)

1. Reflow Soldering

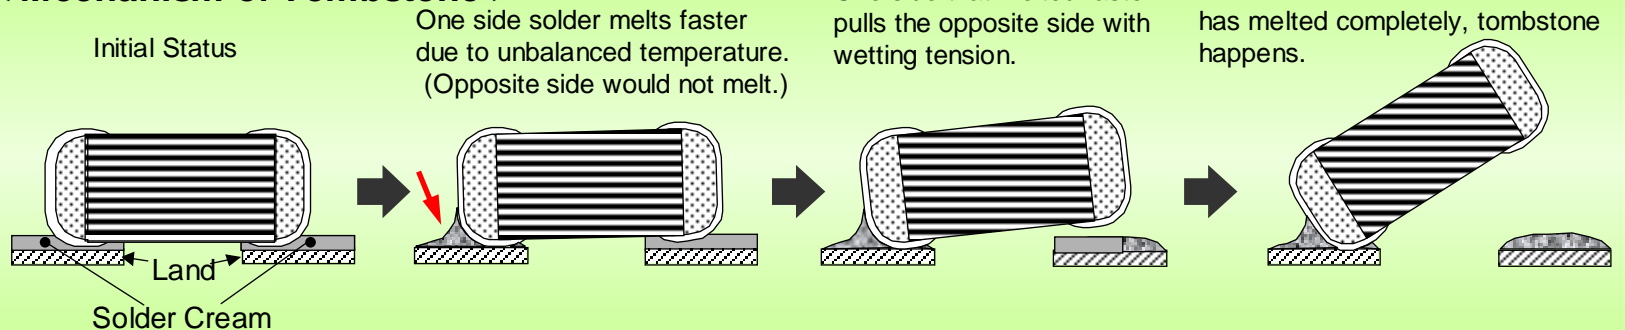
< Mechanism of Tombstone >

In reflow soldering, soldering timing of the right and left electrode might not go together. When soldering timing of cream solder in right and left electrode would be different, tombstone might happen under the below mechanism.

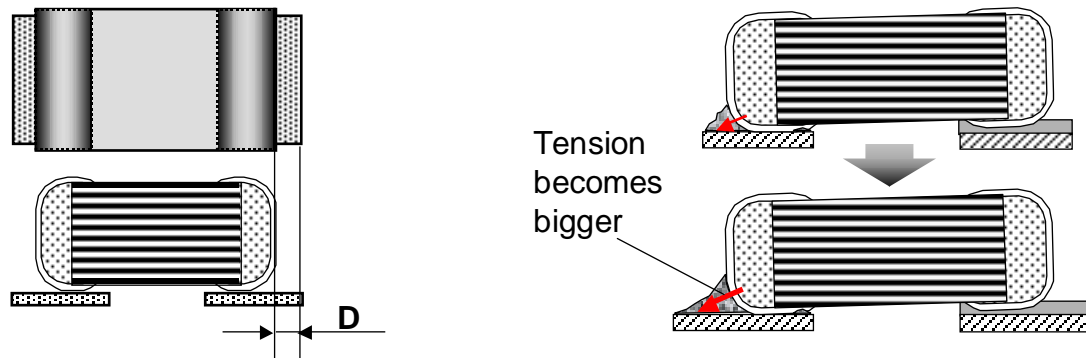
2. Tombstone is controlled by the size of land pattern. When dimension (D) shown in the below chart is bigger, wetting tension becomes larger due to much amount of solder and the possibility of tombstone becomes bigger.

Therefore, special attention should be paid to dimension (D). The recommended land pattern includes its special notice.

3. When land pattern could not be changed to the recommended one shortly, Even a metal mask that is adjusted its dimension to the recommended land pattern could improve tombstone defect sharply.
