For CCFL Inverters
(Eliminates need for Ballast Caps)

Series: **FJ18S**

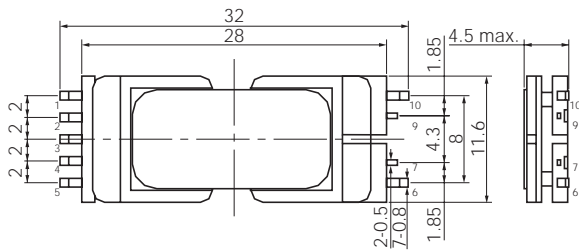
■ Dimensions in mm (not to scale)

Tolerance : ±0.5 mm

Type	Height
FJ18S	4.5 max.
